## Inspection Report

**Property Address:**

123 Main st.  
Phoenix AZ 85302

**One Step Above Home Inspections LLC**

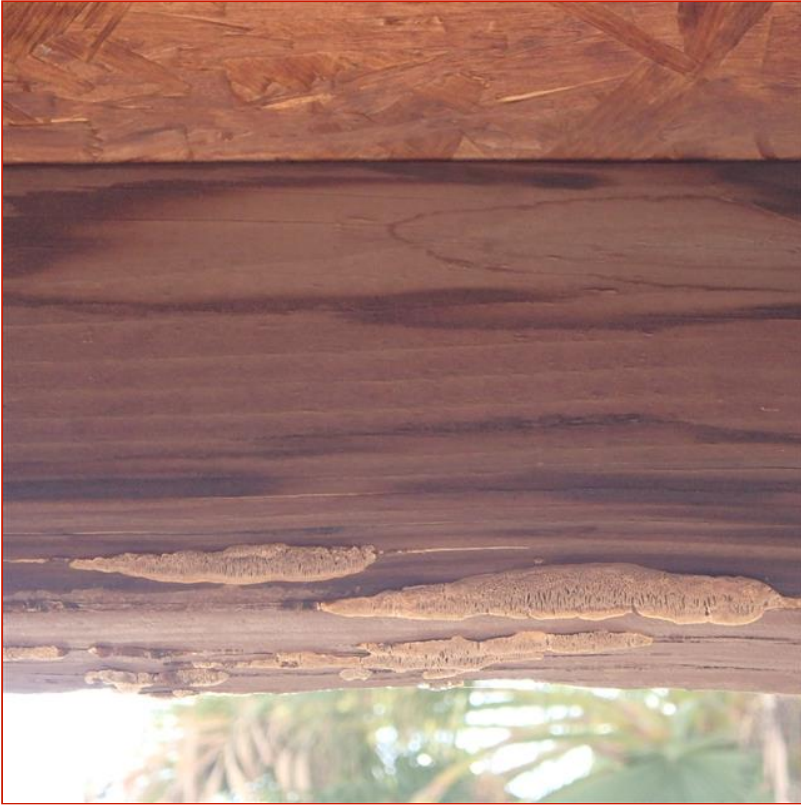
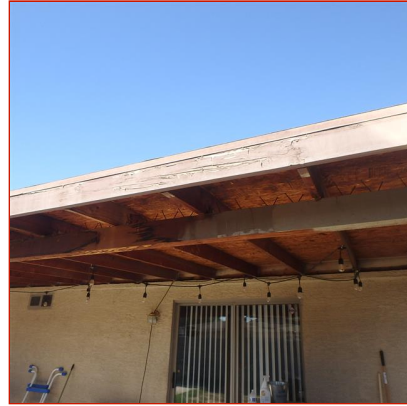
3. (2) Water damaged fascia boards observed at the South. Some repair or replacement is needed. Consult a qualified contractor.

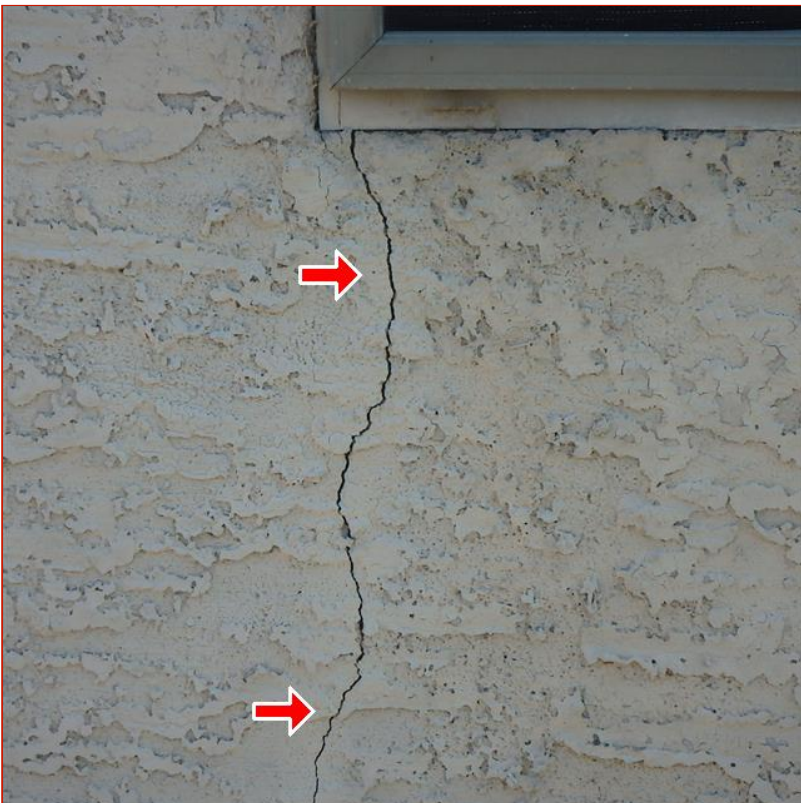
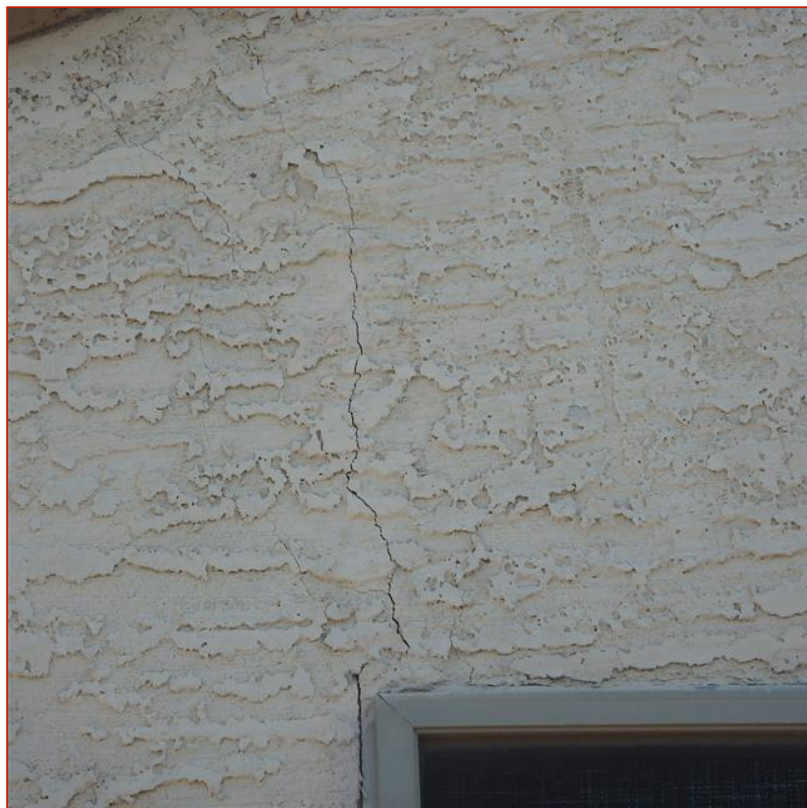
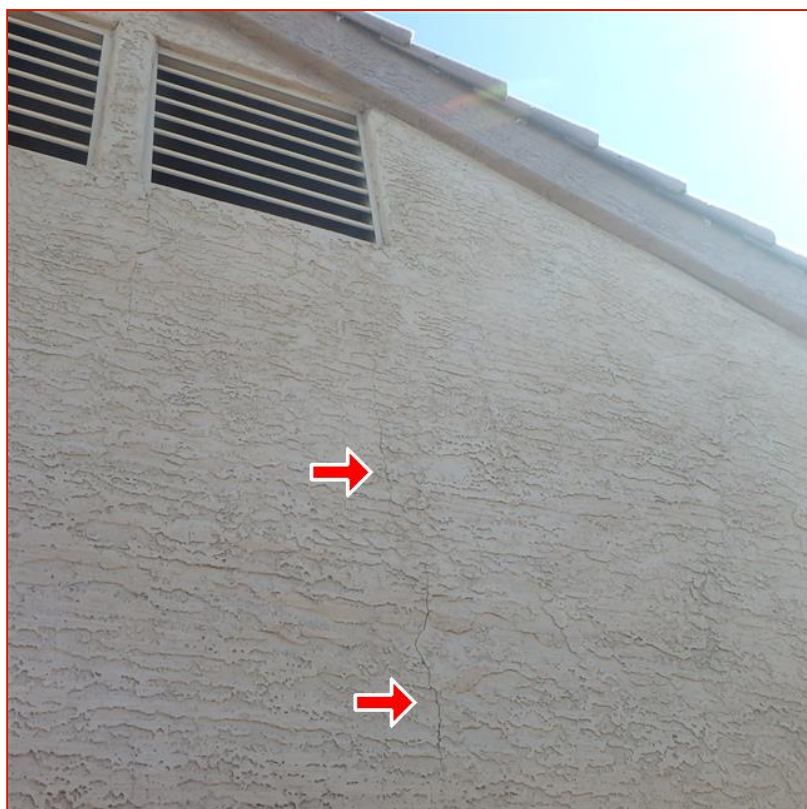
4. (1) The cracks in the stucco cladding exceed one sixteenth of an inch in width. Repairs required by a qualified person. These were noted at the ( LOCATION ).

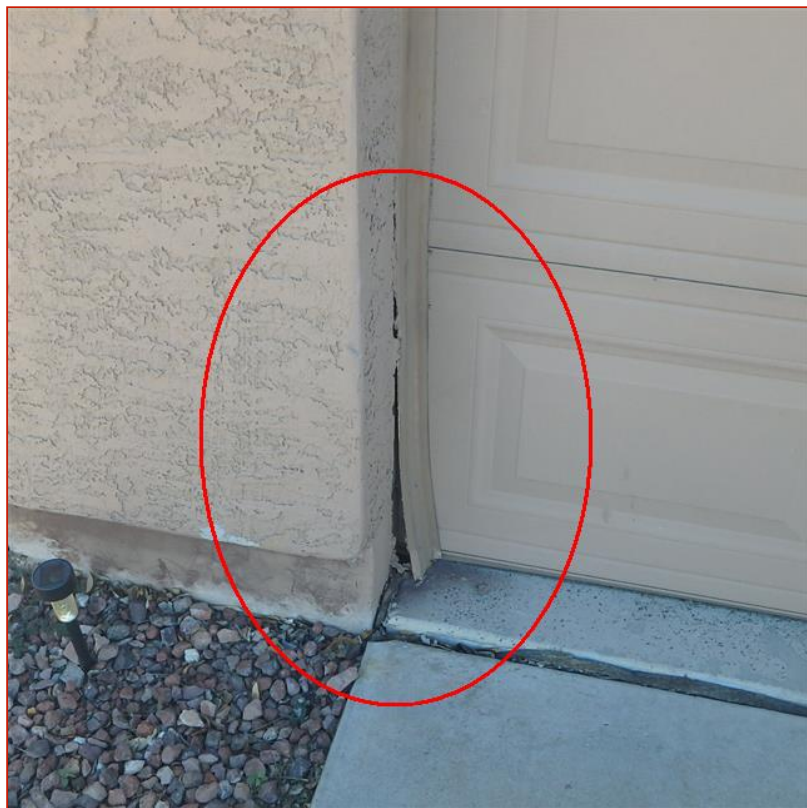
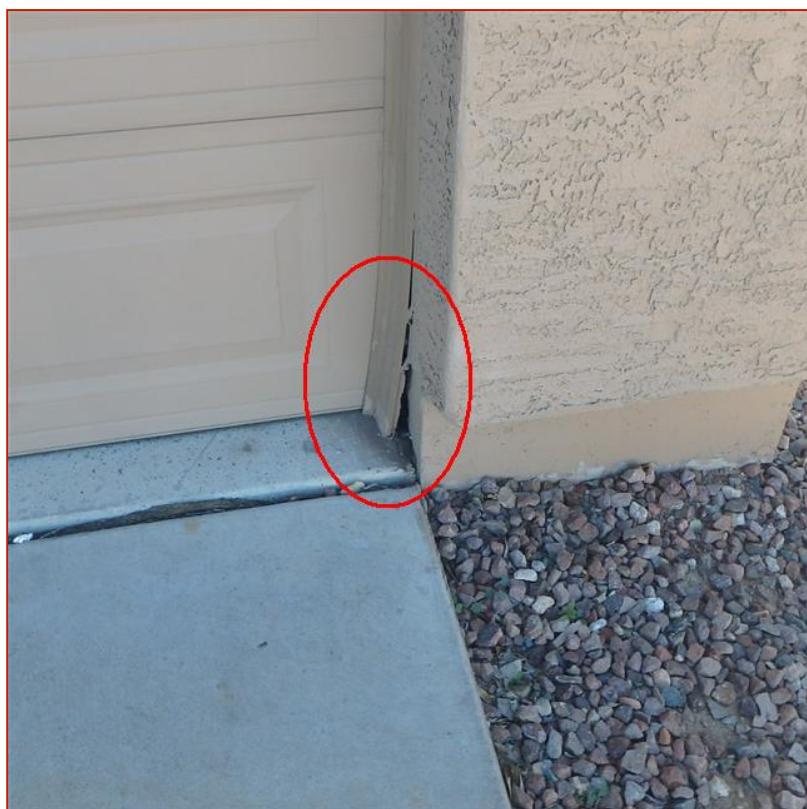
5. (2) The trim at the garage door exhibits one or all of the following conditions. Loose / deteriorated components, water damage and failed caulking. Repairs are recommended.

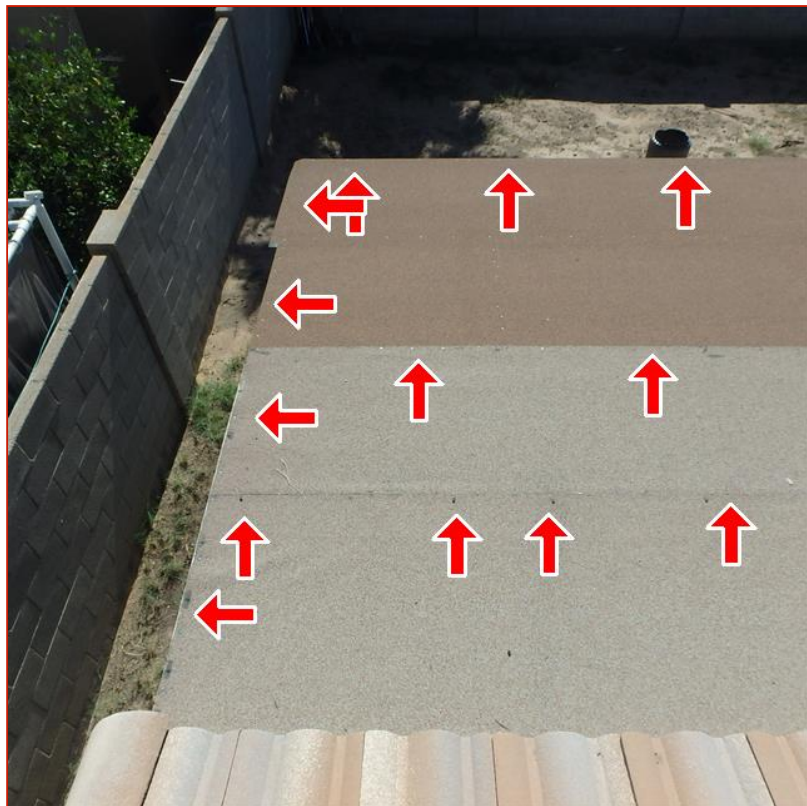
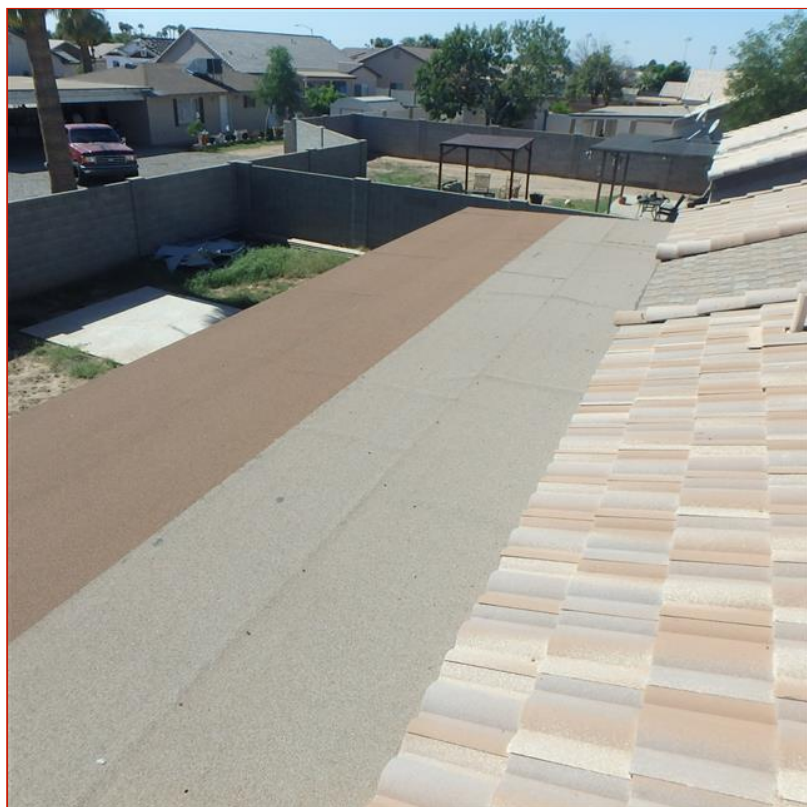
7. (3) Nails or fasteners at the rolled roofing are exposed. To prevent leaks and rusting / popping of nails or fasteners all should be sealed with roof mastic or a compatible sealant by a qualified person.

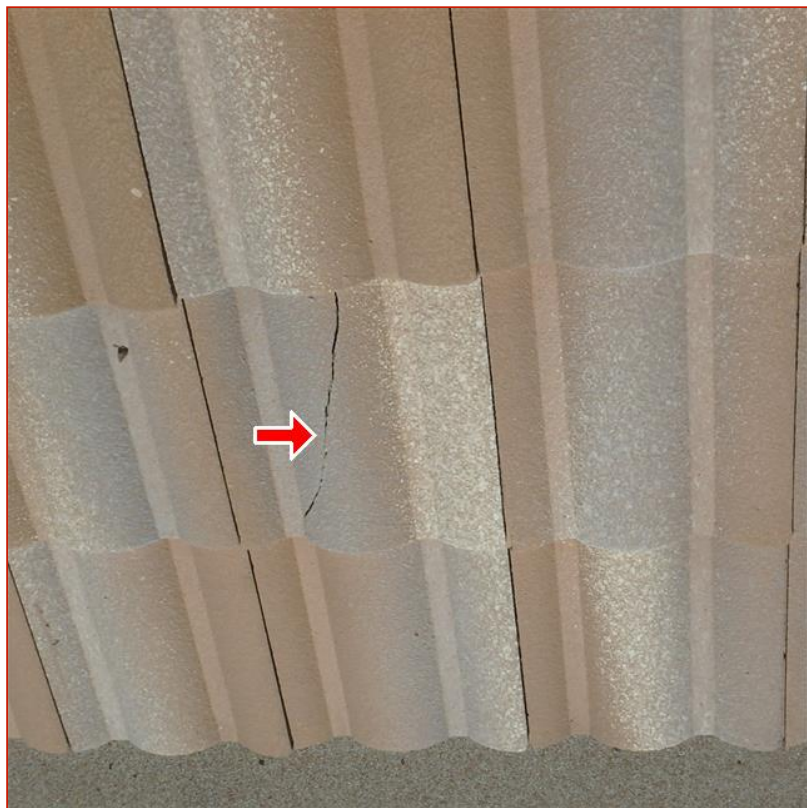
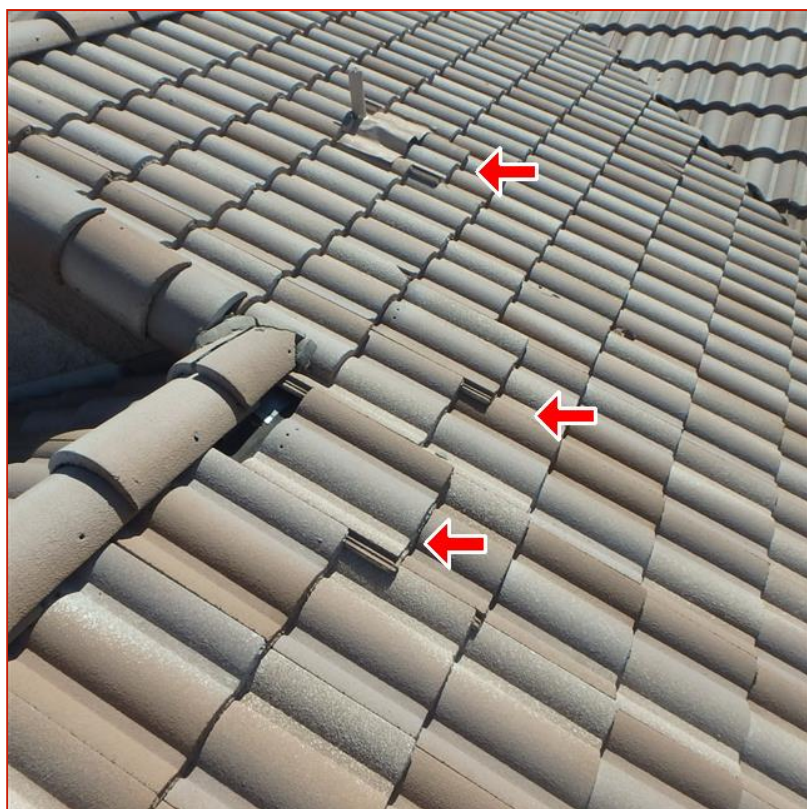
8. (4) There are cracked and dislodged tiles along the ridges and several fields of the roof. However, since the felt underlayment is exposed, repairs are needed. A qualified technician could make repairs or modifications as necessary.

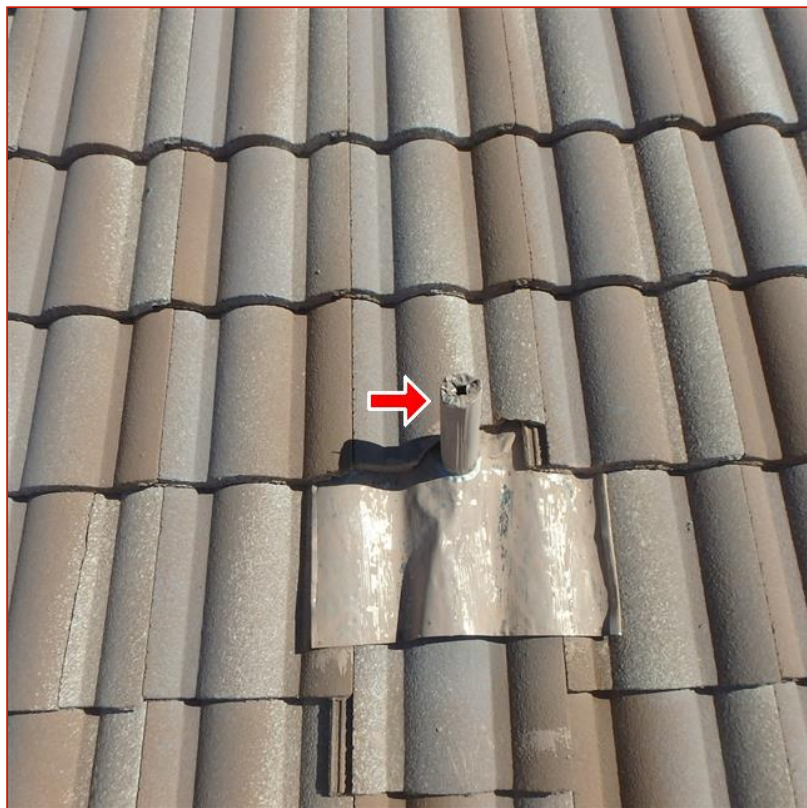
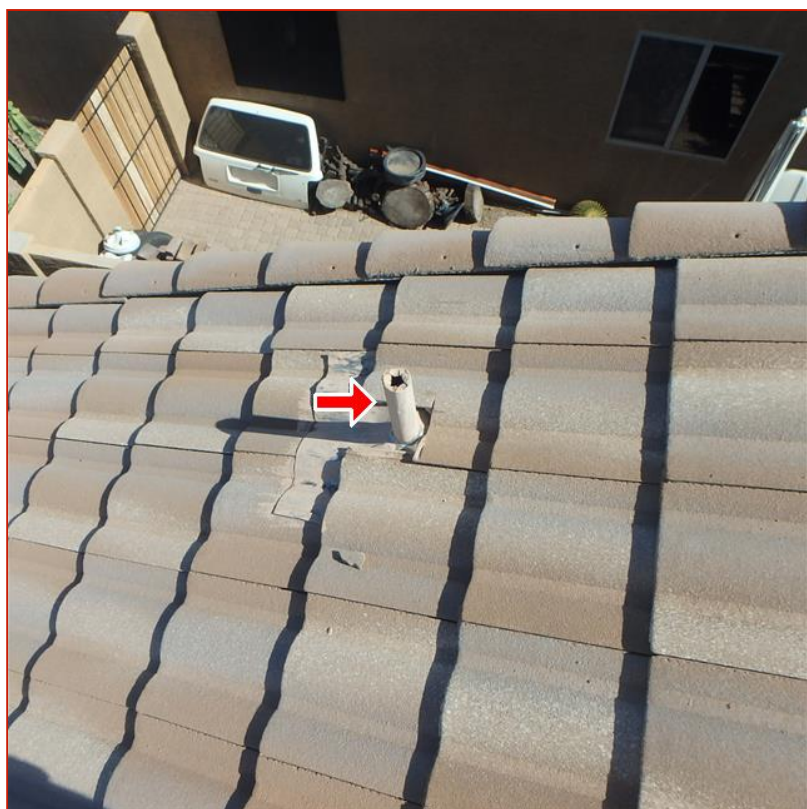
9. (2) One or more of the metal roof jacks installed over the plumbing vents was not properly wrapped into the pipe. This installation is below standard, can develop leaks and restricts the free flow of air that the vent was intended for.

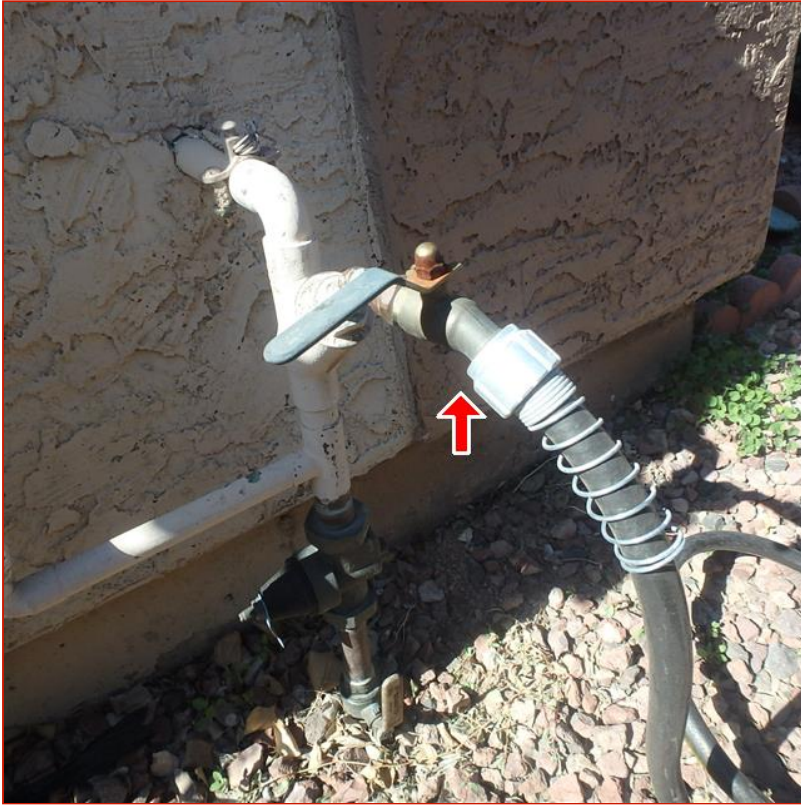
10. A backflow prevention device is not installed as required on the exterior hose bibs on the building. The backflow device helps to prevent contamination of the potable water supply.
- SUGGESTION: Backflow devices should be installed on all exterior hose bibs in accordance with industry standards.

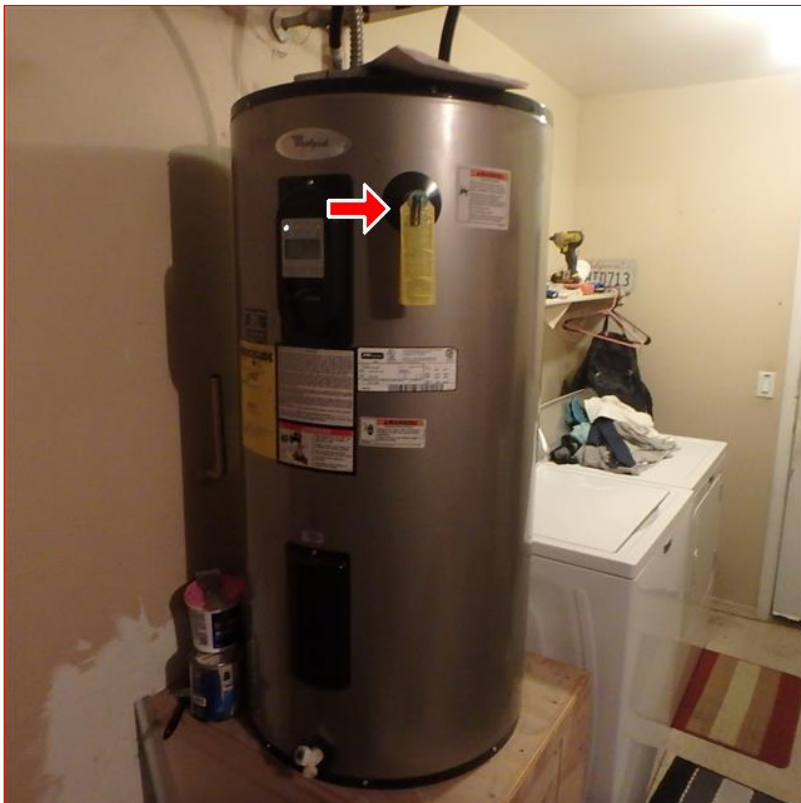
11. (2) There is no discharge pipe on the temperature-and-pressure (T&P) valve. This can be unsafe, and can flood the adjacent area. A qualified plumber could install a discharge pipe that meets the valve manufacturer's specifications.

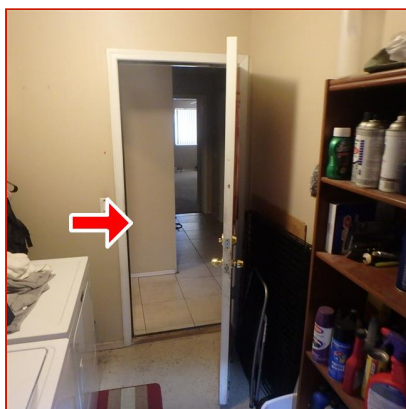
14. The passage door is fire-rated and equipped with an automatic self closer. However, the door does not fully close and latch. The door and/or door self closing hardware should be repaired, replaced or adjusted to ensure that the door closes and latches properly by a qualified contractor.

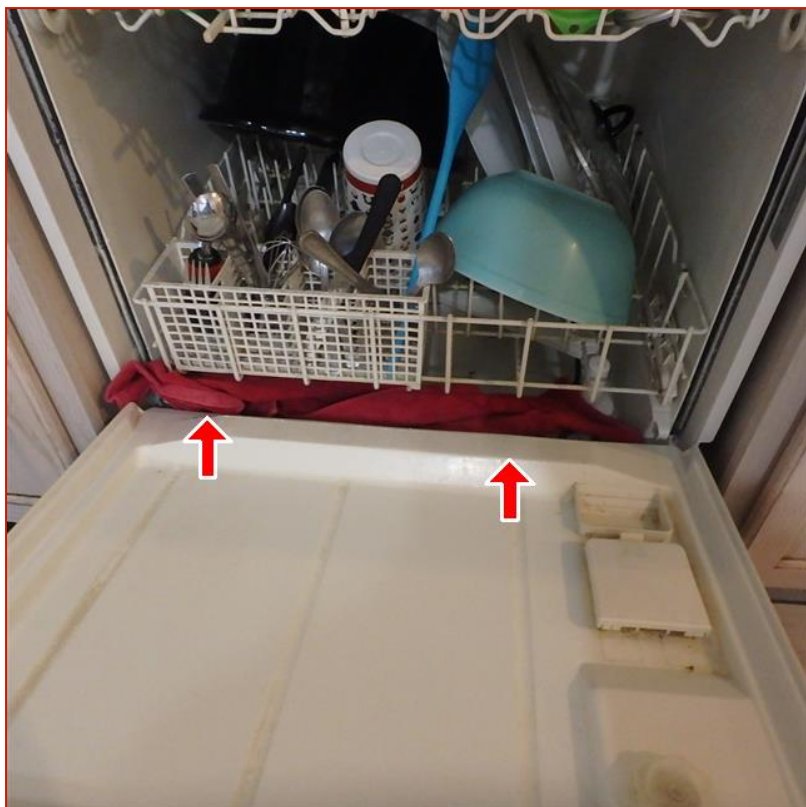
16. The dishwasher door gasket is defective. This can allow water to leak around the door. Have a qualified technician evaluate and replace as necessary.

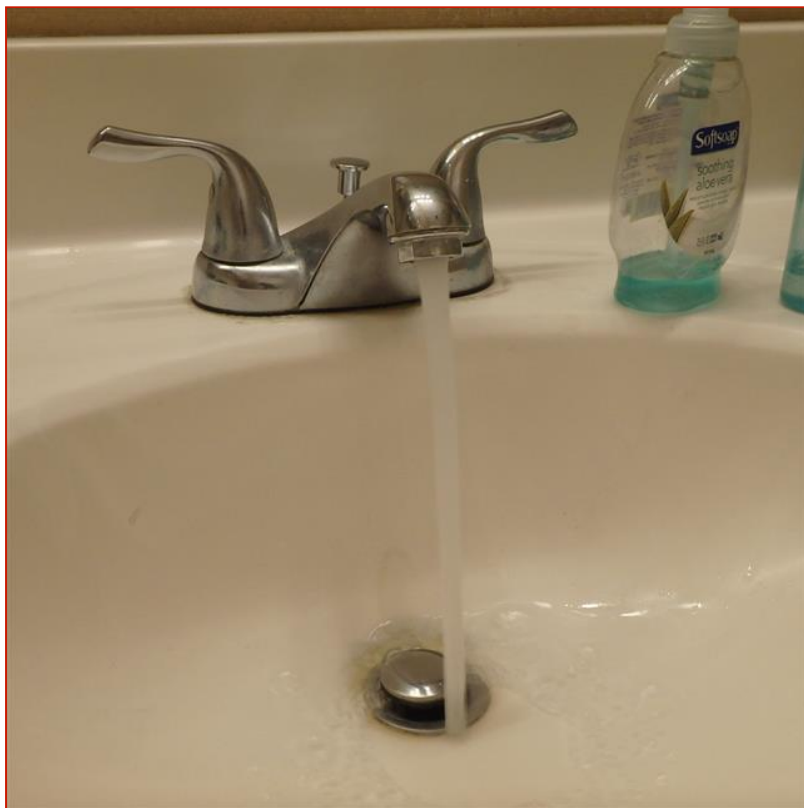
17. (2) A defective regulator cartridge was noted at the Hall Bathroom faucet. The flow of water will not turn off when the handle is turned to the off position. The faucet and cartridge should be evaluated by a qualified person.

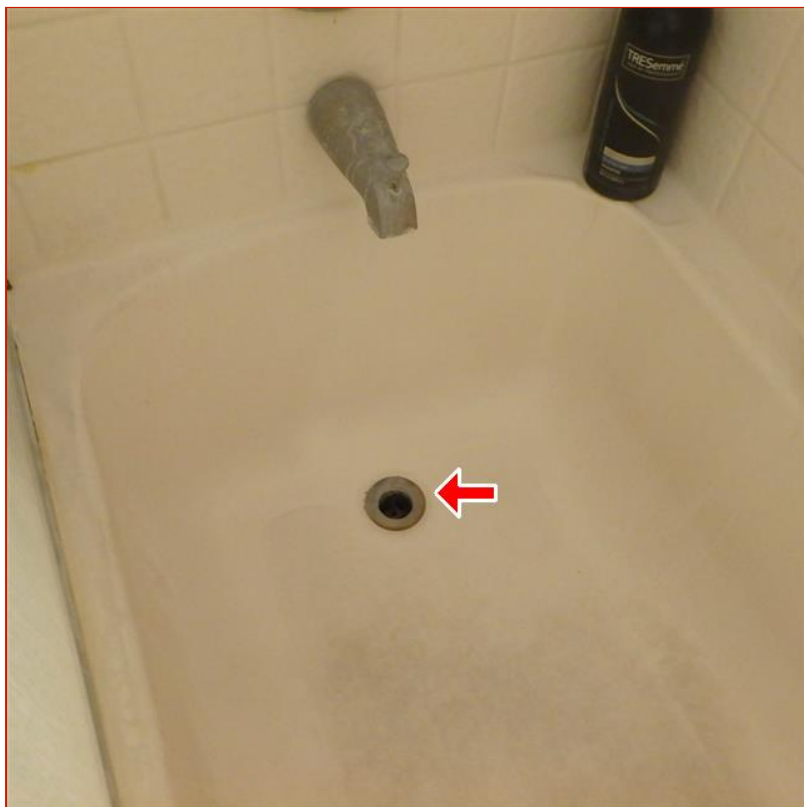
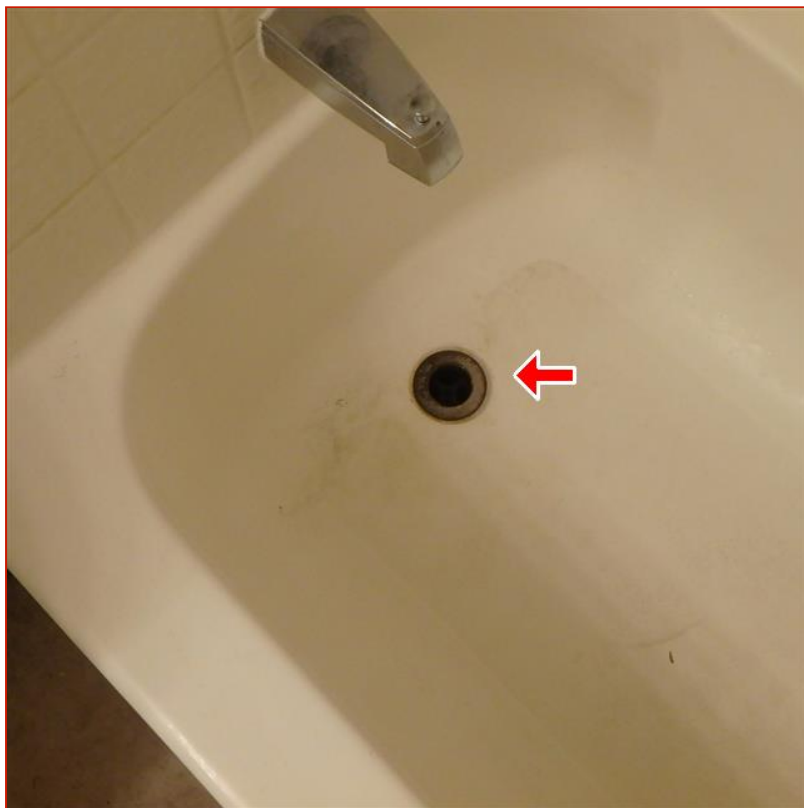
18. (1) One or more of the bathtub drain stops are missing. These are the pop up type that are easily replaced.

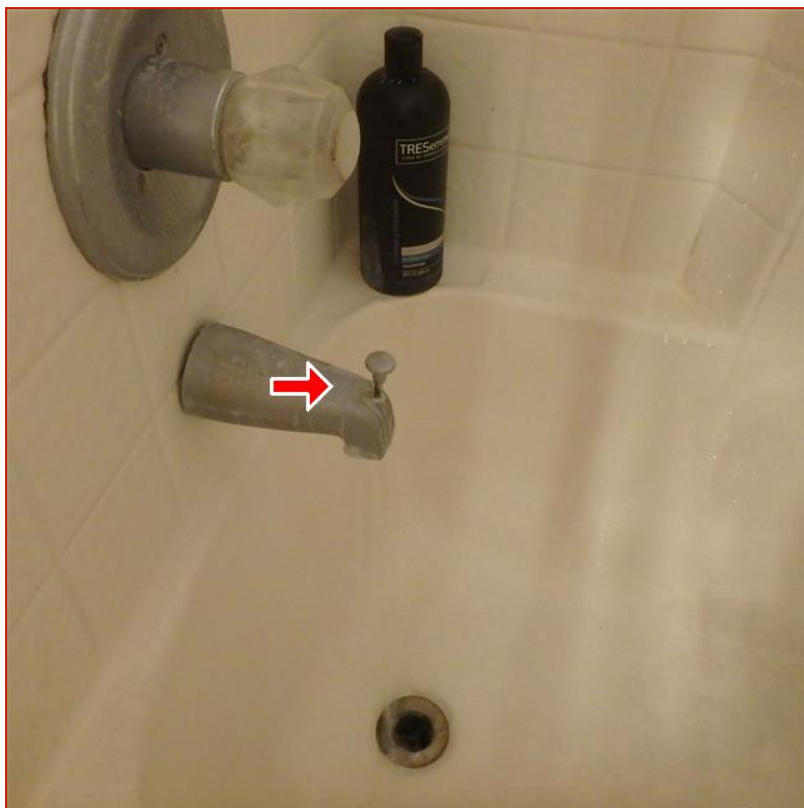
19. (2) A shower diverter valve in the Master Bathroom is frozen and does not operate. The diverter valve and spout (if diverter is not removable type) will need replacement.

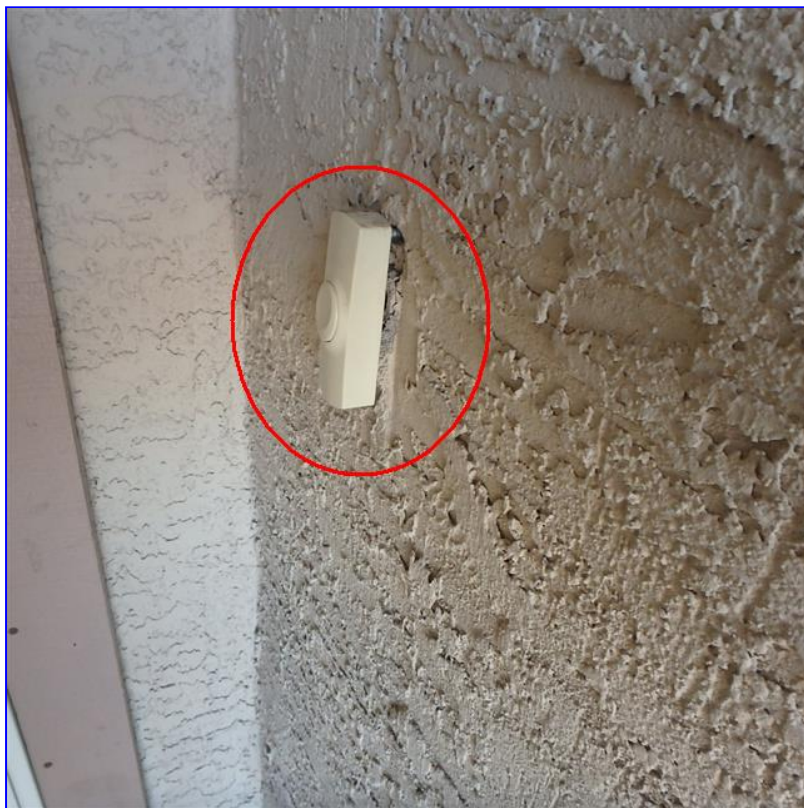
25. (2) The doorbell is functional but loose on the wall. The doorbell should be repaired.

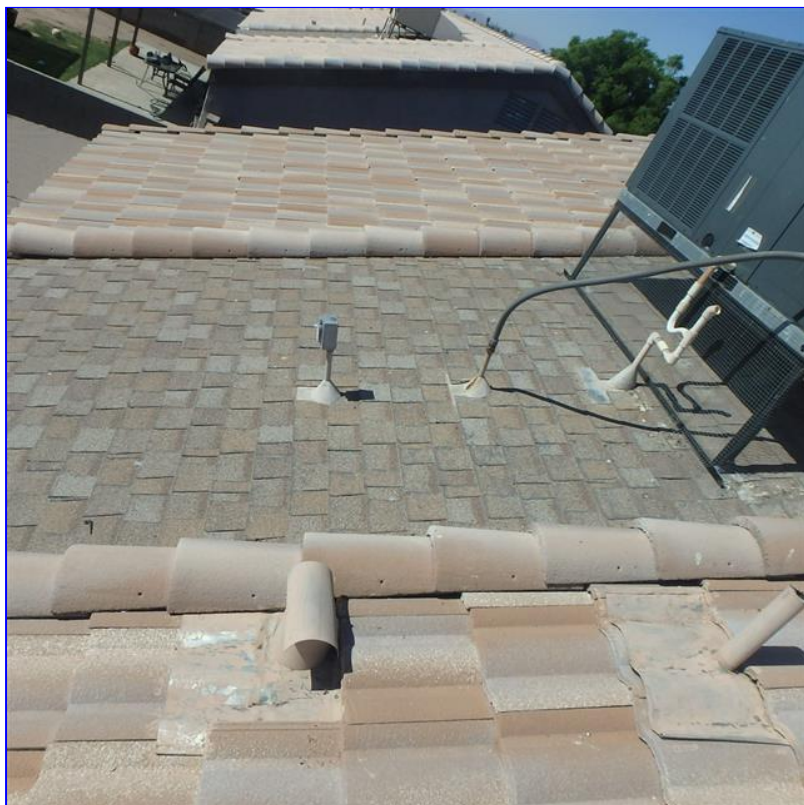
26. (1) The rear of side of the roof, the surface of the composition shingles is brittle, indicating advanced age and weathering. This condition indicates that the roof covering is approaching the end of its service life.

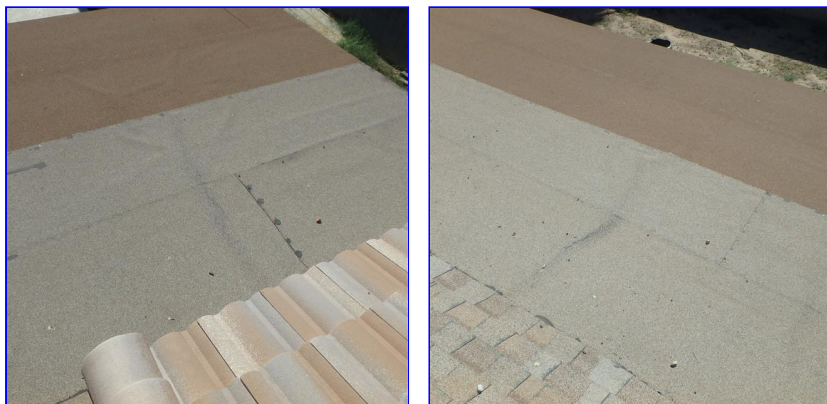
27. (2) Rolled Roof system over the rear patio area This is a composition style shingle in much bigger sizes. Flat and/or low gradual sloped construction. Loose seams (fish mouthing) and Inadequate overhang of the roof system observed at the edges of the roof dip line. This is allowing water to wick around the roof systems and causing damage to the trim materials and the roof decking. We suggest further review by a licensed roofing contractor for proper repairs. The roof appears to be in the second third of its useful life.

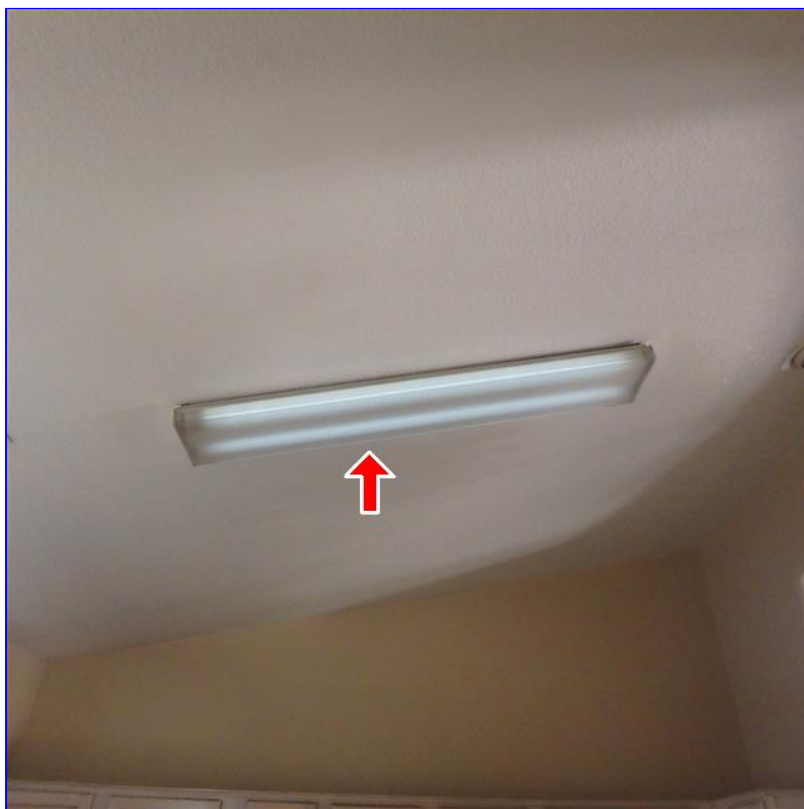
28. Lights in the kitchen are not completely functional. The bulbs may have been damaged. Try replacing the bulbs, and test the fixtures. If a new bulb does not correct the problem, a qualified electrician should make repairs or modifications as necessary.

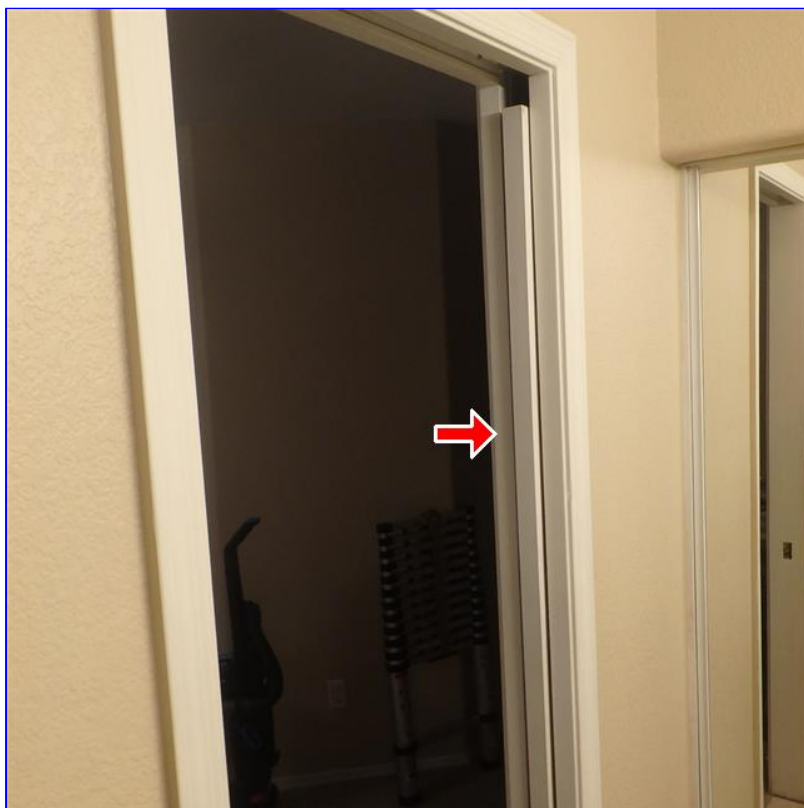
32. One or more closet/pocket doors are off their tracks and not operating properly. A qualified technician should make repairs or modifications as necessary.

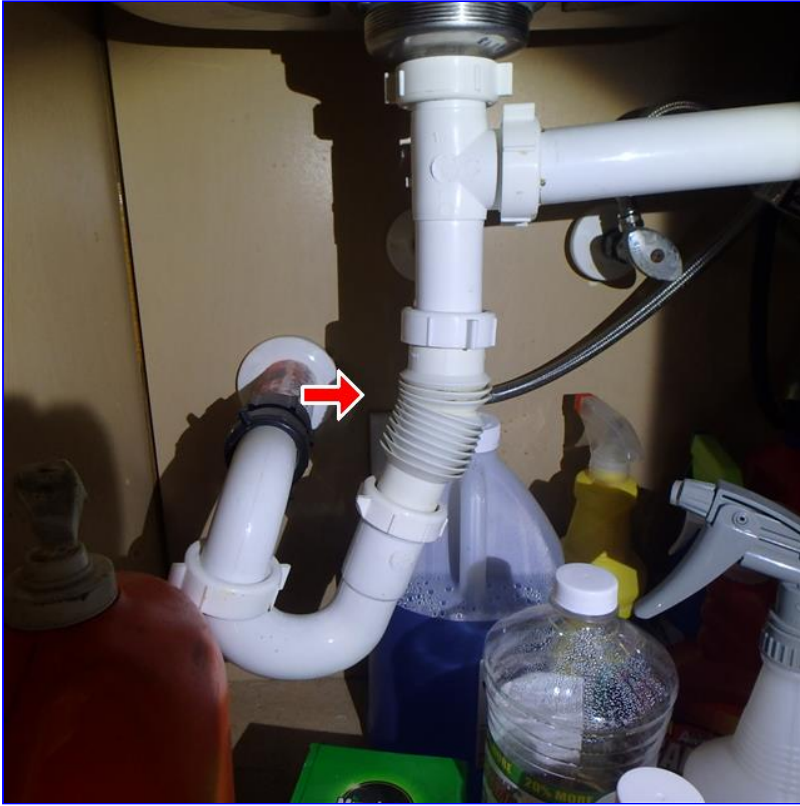
33. (2) A nonconforming flexible rubber or plastic drain fitting is present under the kitchen sink. Modification would be considered optional. However, flexible drain fittings are prone to clogging. These are typically used during re-models, allowing new fixtures to connect with original drain lines.

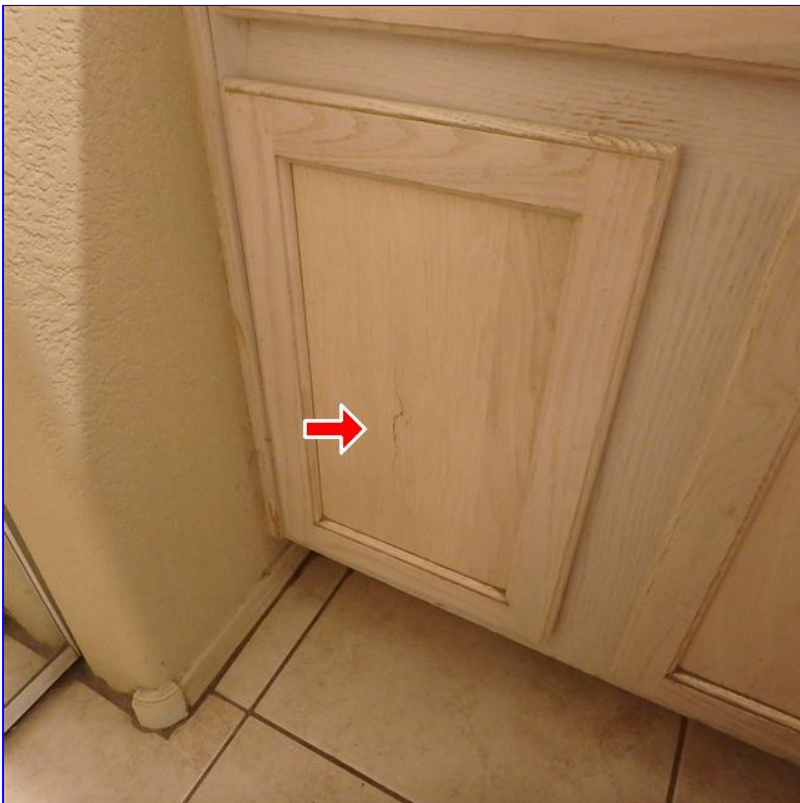
34. One or more cabinet door(s) in the master bathroom is damaged. Missing or damaged doors should be replaced to restore the appearance and function of the cabinets.

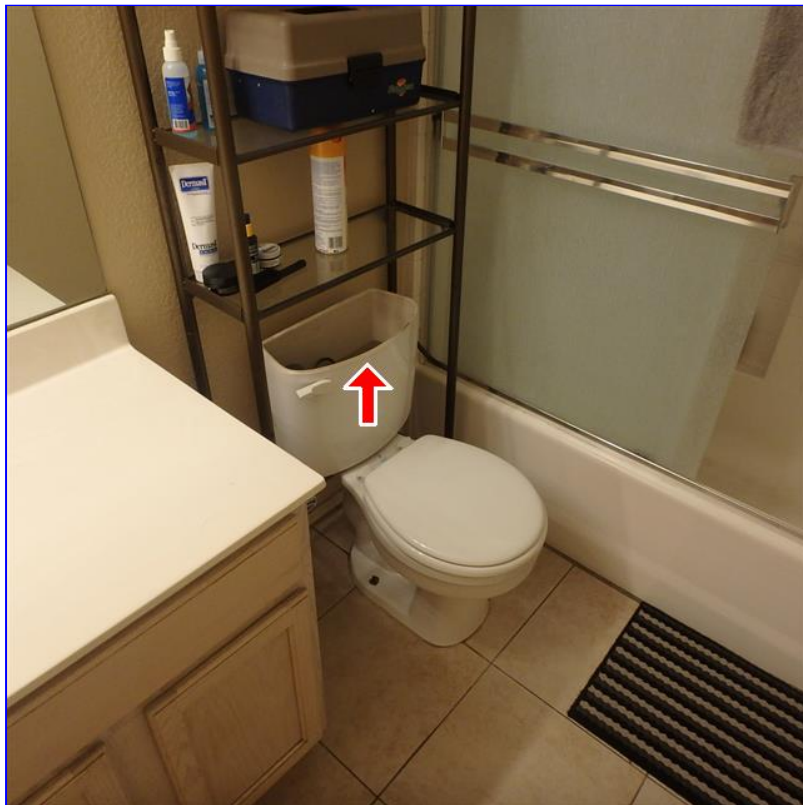
35. The toilets flushed and were not loose on the day of the inspection. The master bathroom toilet is missing it lid. Recommend replacing the lid if able.
